DATE: 9 November 2021

SUBJECT: Main Landing Gear Bolt Inspection and Adjustment

Pelegrin Ltd.

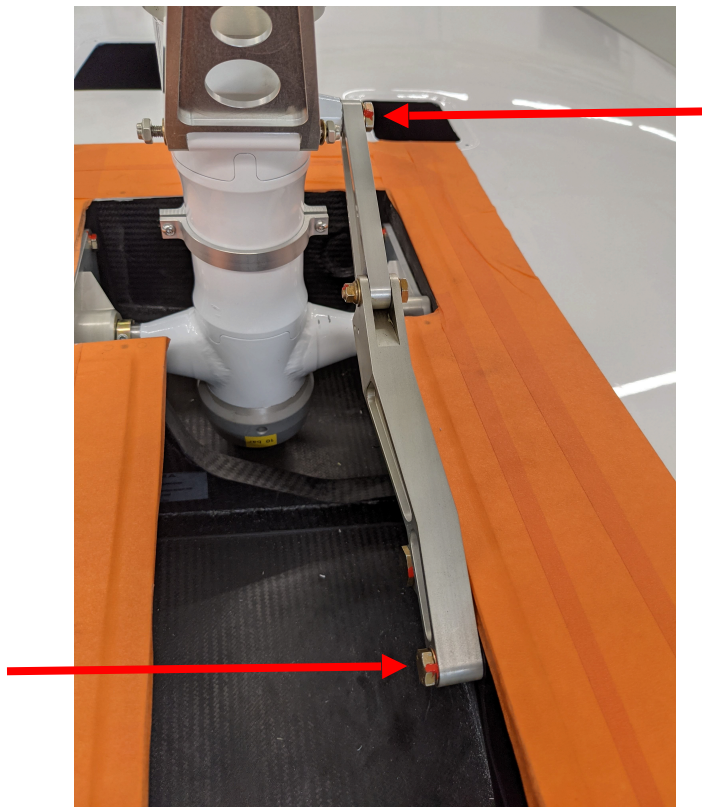
Figure 1 Bolt locations

Reports have been received of main landing gear side strut bolts becoming loose over time. Left uncorrected, this condition could cause the main landing gear to not fix in down or up position, leading to unsafe landing conditions with partially extended landing gear.

1. Get under the wing from the front.
2. Visually inspect if the both bolts shown in Figure 1 are tight. Torque seal must be intact (colored line not broken).
3. If any bolt is not tight and/or the torque seal indicates the bolt has moved, do not fly. Proceed to procedure B to fix the issue.
4. Repeat the procedure for the other main landing gear.

1. Place the aircraft on a jack stand. Use two under the wings and one under the tail.
2. Get under the wing from the front.
3. Remove two bolts shown in Figure 1.
4. Clean the bolts to ensure there is no oil, dirt, sealant or paint on the treads.
5. Apply a few drops of Loctite Blue on the end of the bolt.
6. Put the bolt back in place and twist to secure it.
7. Use torque seal paint to mark the secured location of the bolt (as in Figure 1).
8. Let the Loctite fully cure for 24 hours before removing it from the jack stands.
9. Repeat the procedure for the other main landing gear.

1. After letting Lotite to cure for 24 hours, check that bolts are tight and torque seals are in place.
2. Remove aircraft from the jack stands.
3. Make a log book entry to note the inspection performed referencing this service bulletin and return aircraft to service.
